| Application | HVAC |

CCS-FR-17 | ISSUED 08/2017

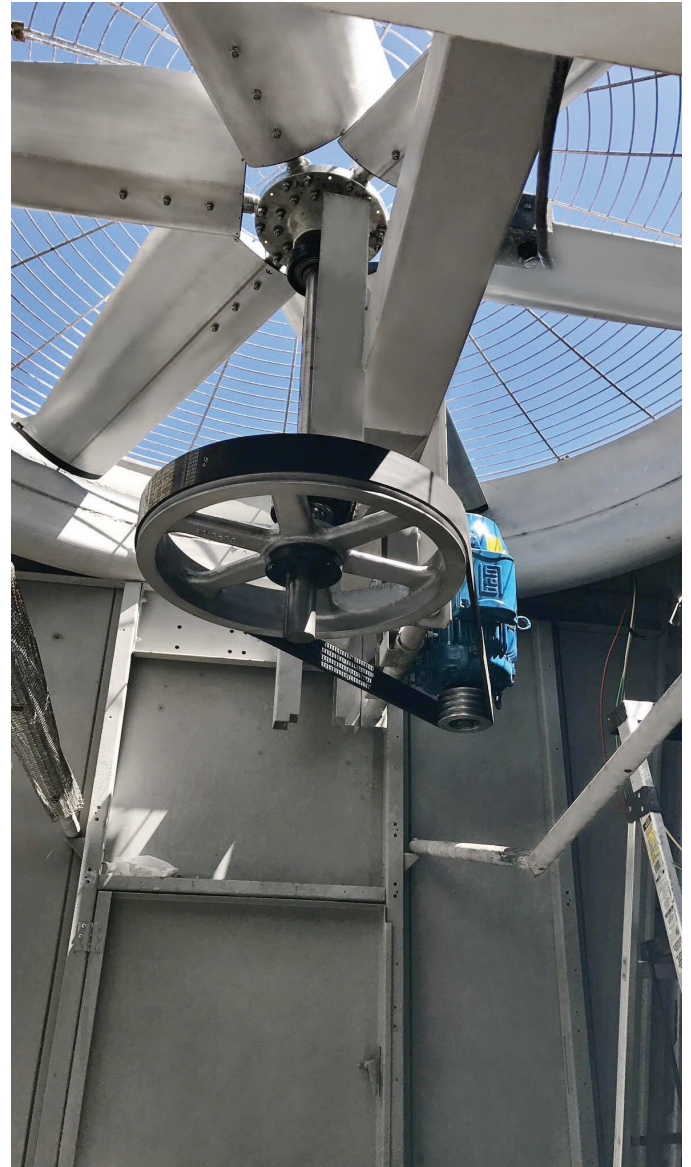
| Problem | Components were beginning to fail. Sheaves fractured and the fan shaft and blades corroded, increasing the potential for major damage to the tower. |

| Solution | Replaced failing parts with Marley® components, including X7 fan, bearings, fan shaft, belt, basin covers, motor, sheaves and bushings. |
| Results | Tower restored to safe and efficient operating level; tower life extended |
