Vibration Troubleshooting

Vibration Switch Troubleshooting

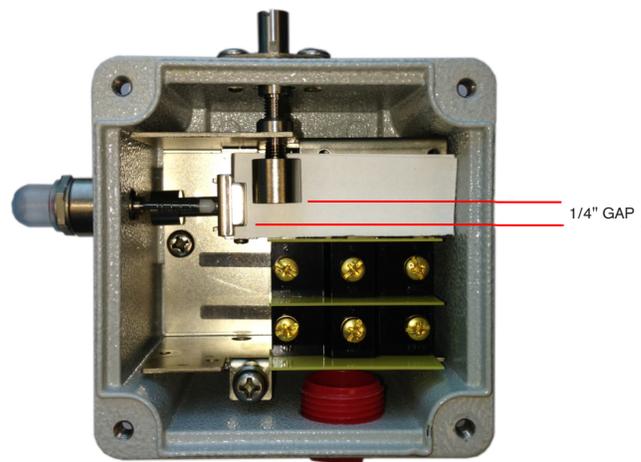
IMI685A Mechanical Switch

To confirm factory setting remove the cover and measure the gap distance between the edges of the cylinder and the square magnet. If the gap setting is not 1/4" rotate the adjustment screw clockwise or counter clockwise until a 1/4" gap is obtained.

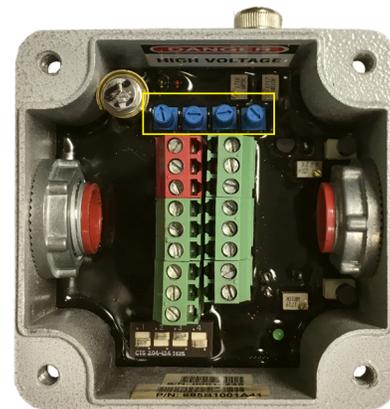
IMI685B Electronic Switch

The 685B should be set to 0.6in/s alarm and 0.7in/s shutdown. Verify it is set properly.

Alarm (shutdown) at
.7 in/s with
3 sec time delay

Alert (notification)
at .6 in/s with 45
sec time delay
